## Appendix 2

Airbus's examples of the inspection and modification (including design change) for PDA prevention

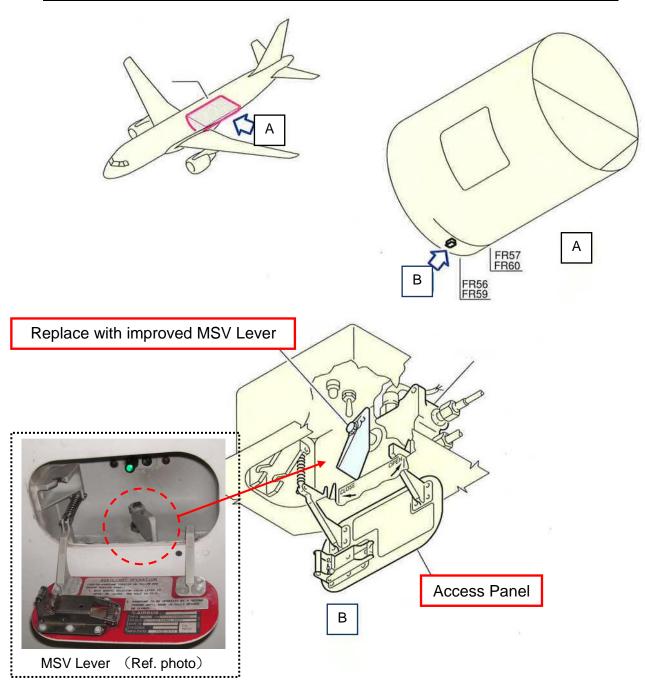
Fig. 2-1

| Model | Title |
|---|---|
| A320 | DOORS - CARGO COMPT DOOR HYD SYSTEM - IMPROVE LOCKING AND |
| | INTERFACE TOLERANCE OF MANUAL SELECTOR VALVE (MSV) LEVER |
| | (SB A320-52-1160) |

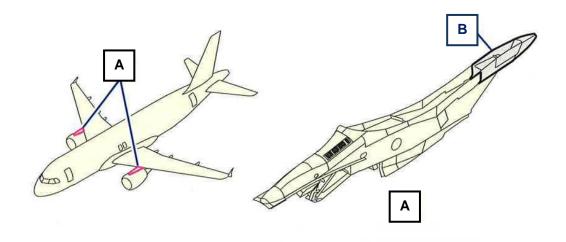
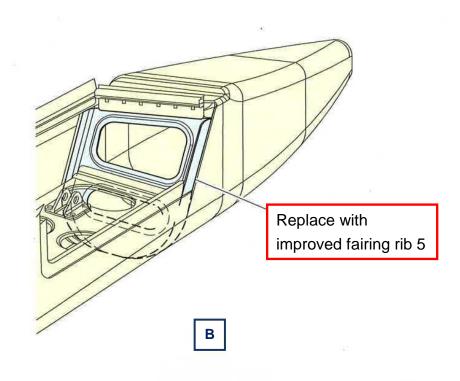
Fig. 2-2

| Model | Title |
|---|--|
| A320 | NACELLE & PYLON – AFT MOVABLE FAIRING – RIB 5 RE-DESINGN |
| | (SB A320-54-1028) |

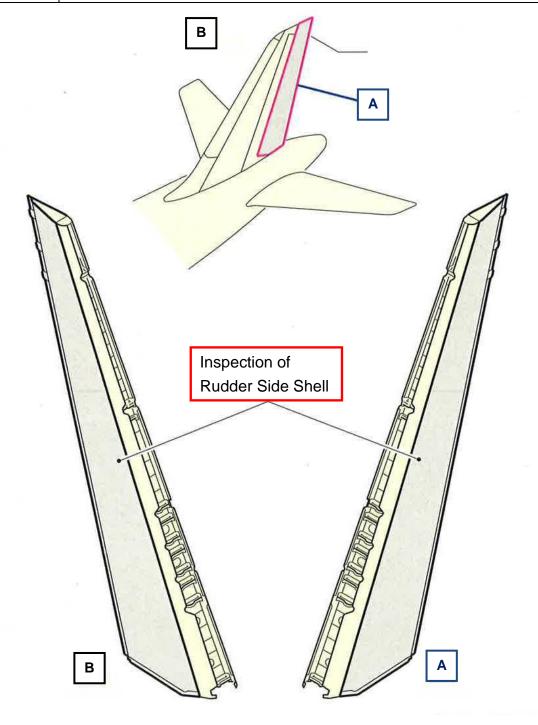
Fig. 2-3

| Model | Title |
|---|--|
| A320 | STABILIZERS - RUDDER SIDE SHELL SANDWICH REPAIR INSPECTION |
| | (SB A320-55-1041) |

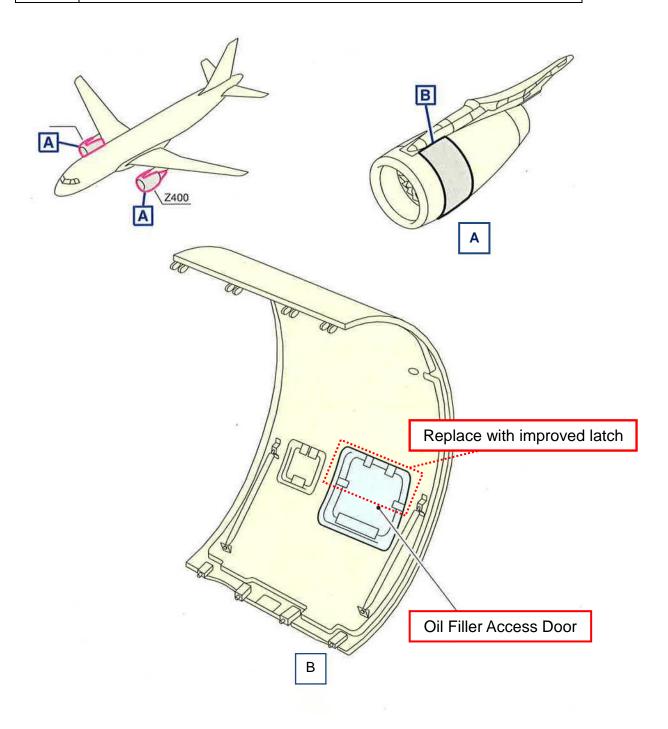
Fig. 2-4

| Model | Title |
|---|--|
| A320 | POWER PLANT - FAN COWL DOORS - INTRODUCE AN IMPROVED OIL |
| | FILLER DOOR LATCH DESIGN ON IAE ENGINE (SB A320-71-1061) |

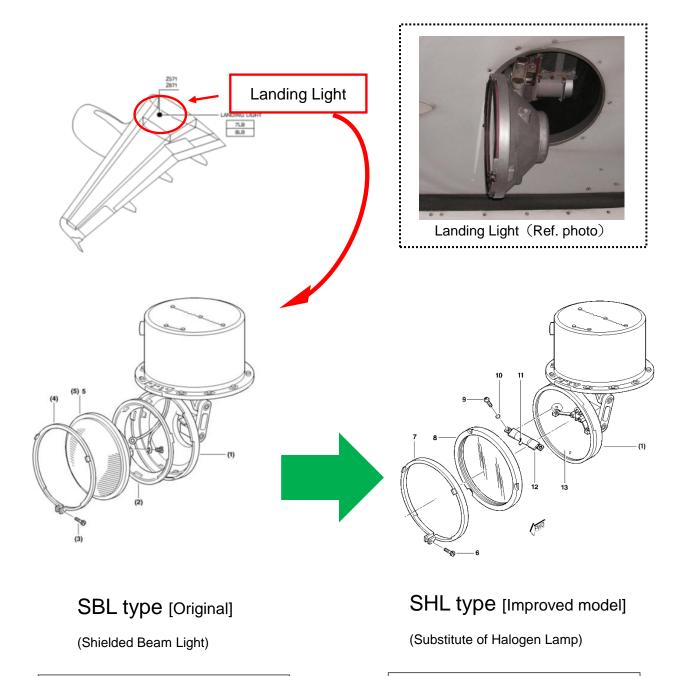
Fig. 2-5

| Model | Title |
|---|--|
| A320 | APPLY SHL TECHNOLOGY ON LANDING LIGHTS (TFU33.42.00.004) |

Light with a reinforced lens and

cracking

without airtightness to prevent lens

Light that is airtight because an incombustible gas is sealed in the

light sough portion

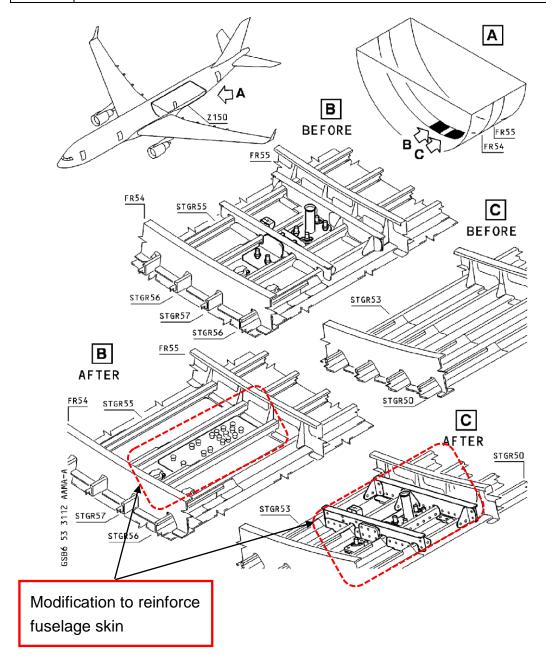
Fig. 2-6

| Model | Title |
|---|---|
| A330 | FUSELAGE - REAR FUSELAGE - RELOCATE VHF 2 ANTENNA |
| | (SB A330-53-3112) |

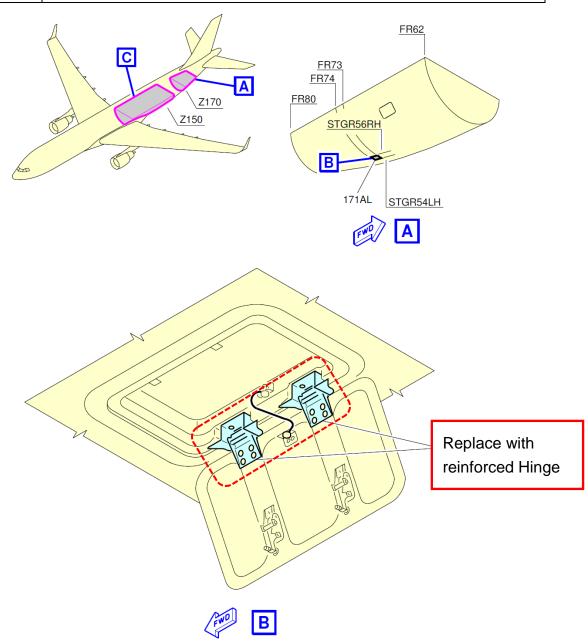
Fig. 2-7

| Model | Title |
|---|---|
| A330 | DOORS – SERVICE DOORS – IMPROVE SERVICE PANEL ACCESS DOORS IN |
| | SECTION 16 AND 18 (SB A330-52-3108) |

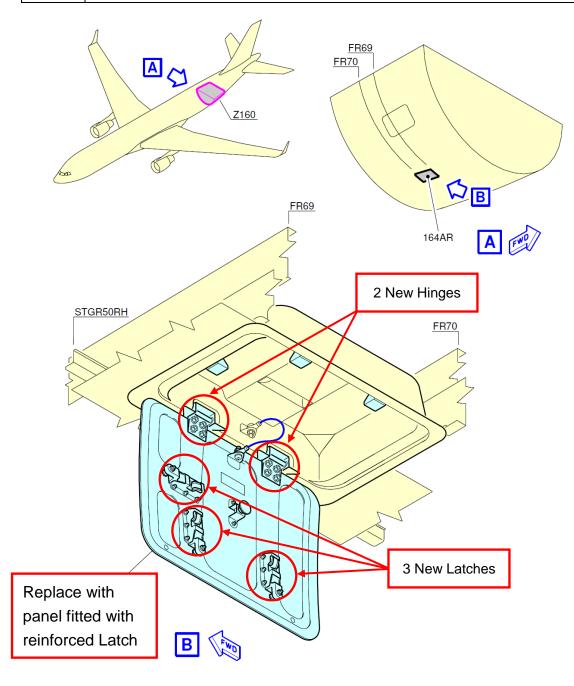
Fig. 2-8

| Model | Title |
|---|---|
| A330 | DOORS - SERVICE DOORS-MODIFICATION OF LATCHING MECHANISM OF |
| | POTABLE WATER SERVICE PANEL (SB A330-52-3086) |
