Implementation of Measures to Prevent Objects Falling off Airplanes

January 2018

Civil Aviation Bureau of Japan,
Ministry of Land, Infrastructure, Transport and Tourism
Association of Air Transport Engineering and Research

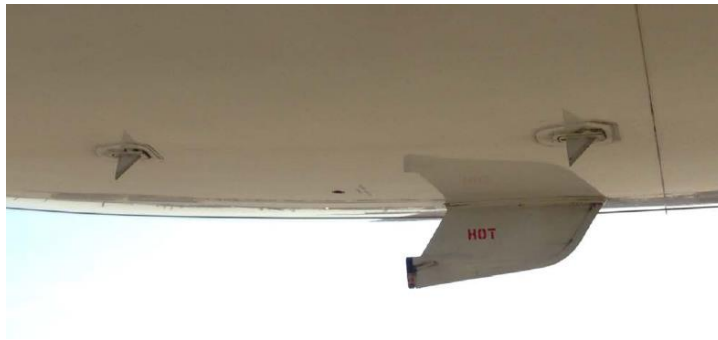
Figure 3-5: Drain mast

A drain mast is installed to discharge water from the galley and lavatory wash-basins. It is always heated during flight and controlled to prevent water from freezing. A failure of this heating function may cause ice blocks to form. It is important to confirm that the heating function of these areas works properly at the time of maintenance.
